2013 CARTRIDGE UPDATES

By Mike Josiah and the Technical Staff at UniNet

DELL 1130 CORE CHANGE

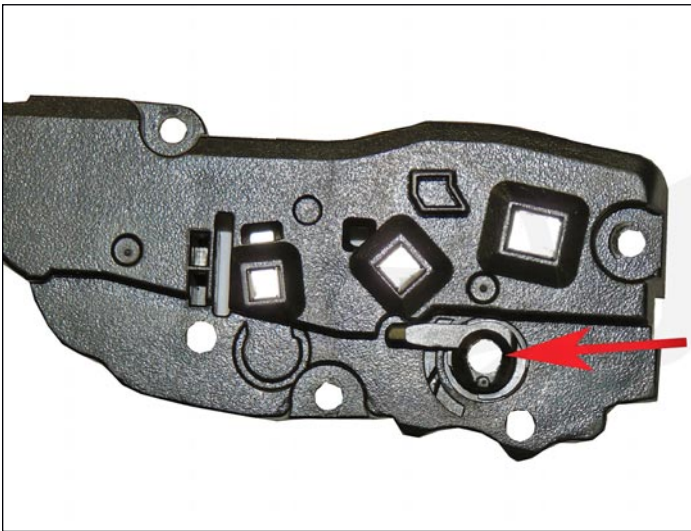
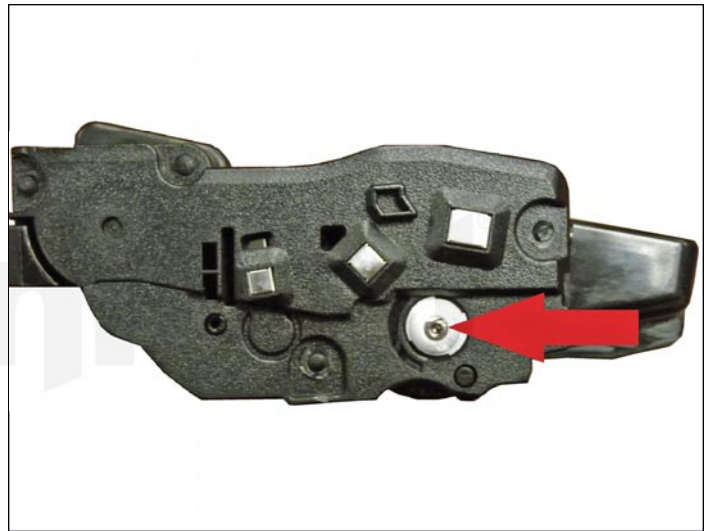
On the left picture you see the older black softer plastic bushing.

The right picture shows the newer (harder) white plastic bushing.

This change was made because the softer black bushings were wearing out in an oblong shape and allowing the drum to move. Depending on the wear, light to severe banding will be seen on the printed page.

Take a look at the cores you have in stock. If you have the newer ones with the white plastic bearings, you should be fine, but if they have the older softer black bushings, inspect them carefully. If the hole is not perfectly round, your test prints will show banding.

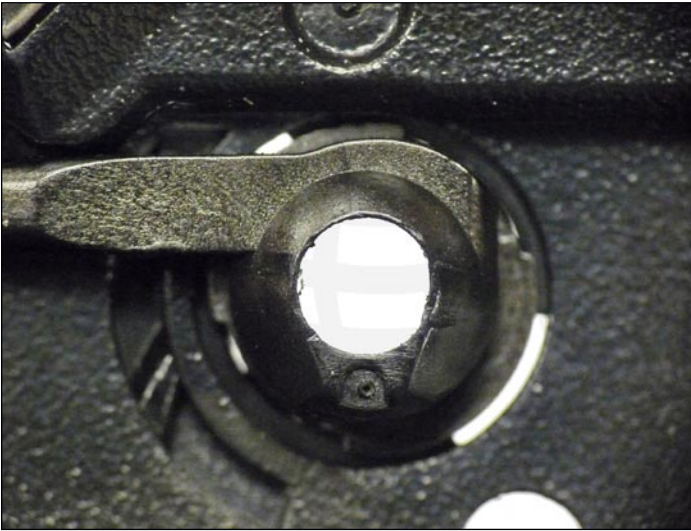
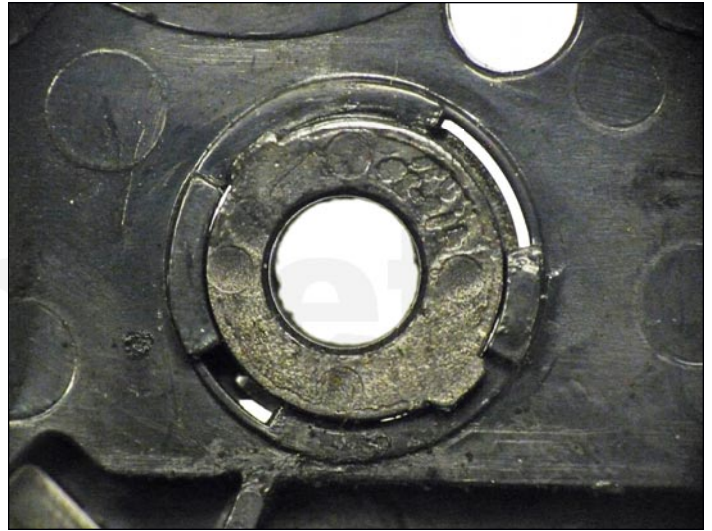
The old style end cap pictures are shown here with black bushings.

If you look at the drum axle bearing hole you'll notice wear marks and that the hole is slightly elongated.

You can also see small strands of plastic hanging off the center of the bearing.

With a cartridge that was banding, when we swapped out the end caps, the problem instantly went away and when we moved the end caps around to different cores, the problem followed them.

No new replacement caps are currently available, but we are currently investigating a replacement bushing and/or end cap system.

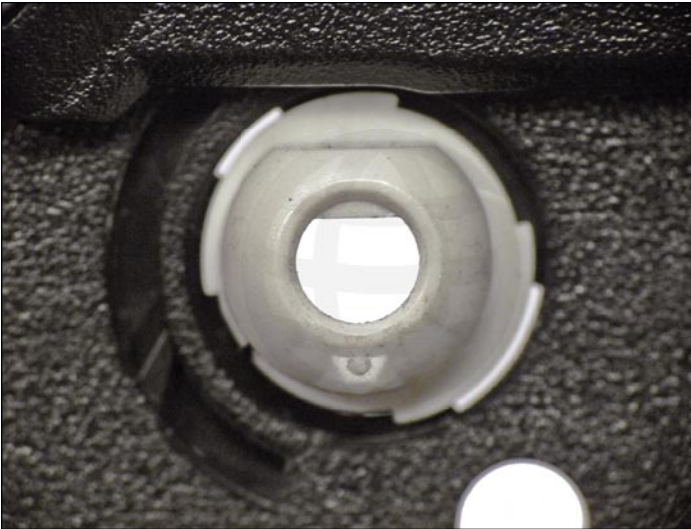
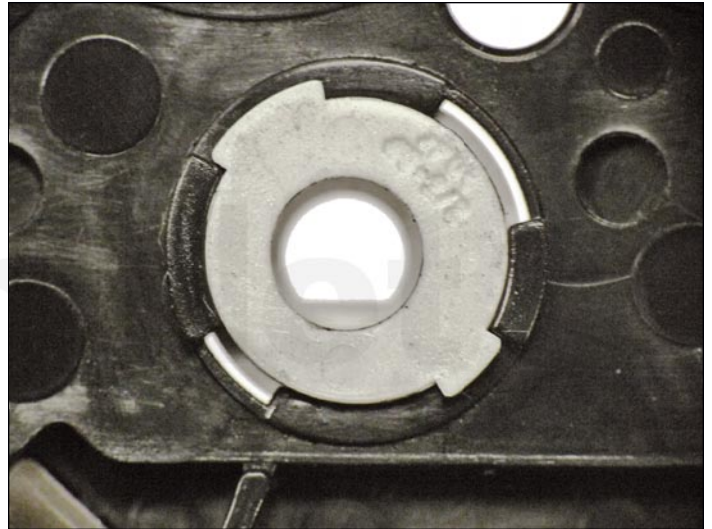
The new end caps have a new drum axle bearing made of a much harder (and what appears to be) self-lubricating plastic.

This is an expensive upgrade so Samsung/Dell must have been having massive issues with these cartridges for them to do that.

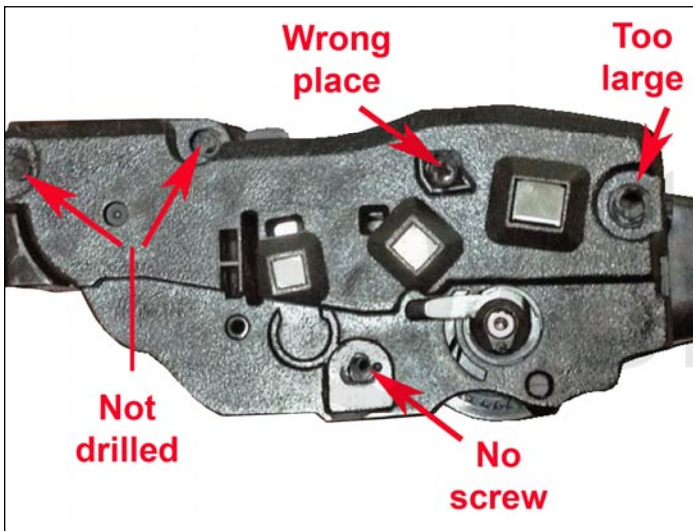
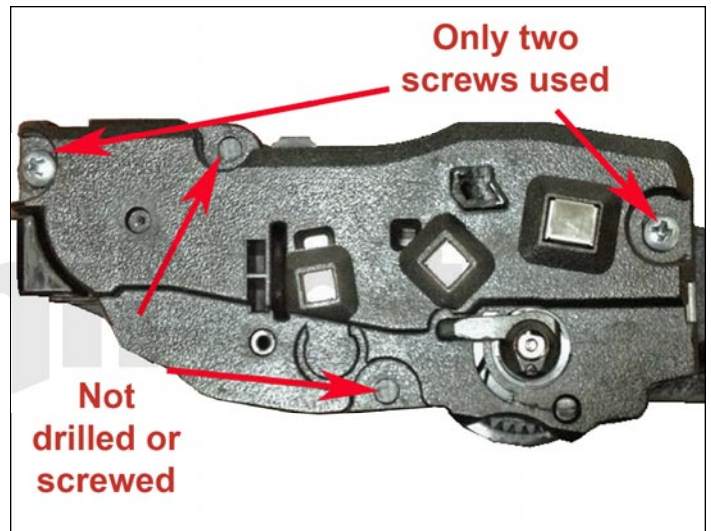
Shown are a few problems: posts were not drilled and screwed; only two screws were used instead of four; an extra screw was installed in the wrong place; and one of the holes (not screwed) is too large for a screw to hold that point in place properly.

Being careful in the initial setup of these cartridges will ensure even printing with no voids or banding and will also ensure you get the maximum life from your cores.

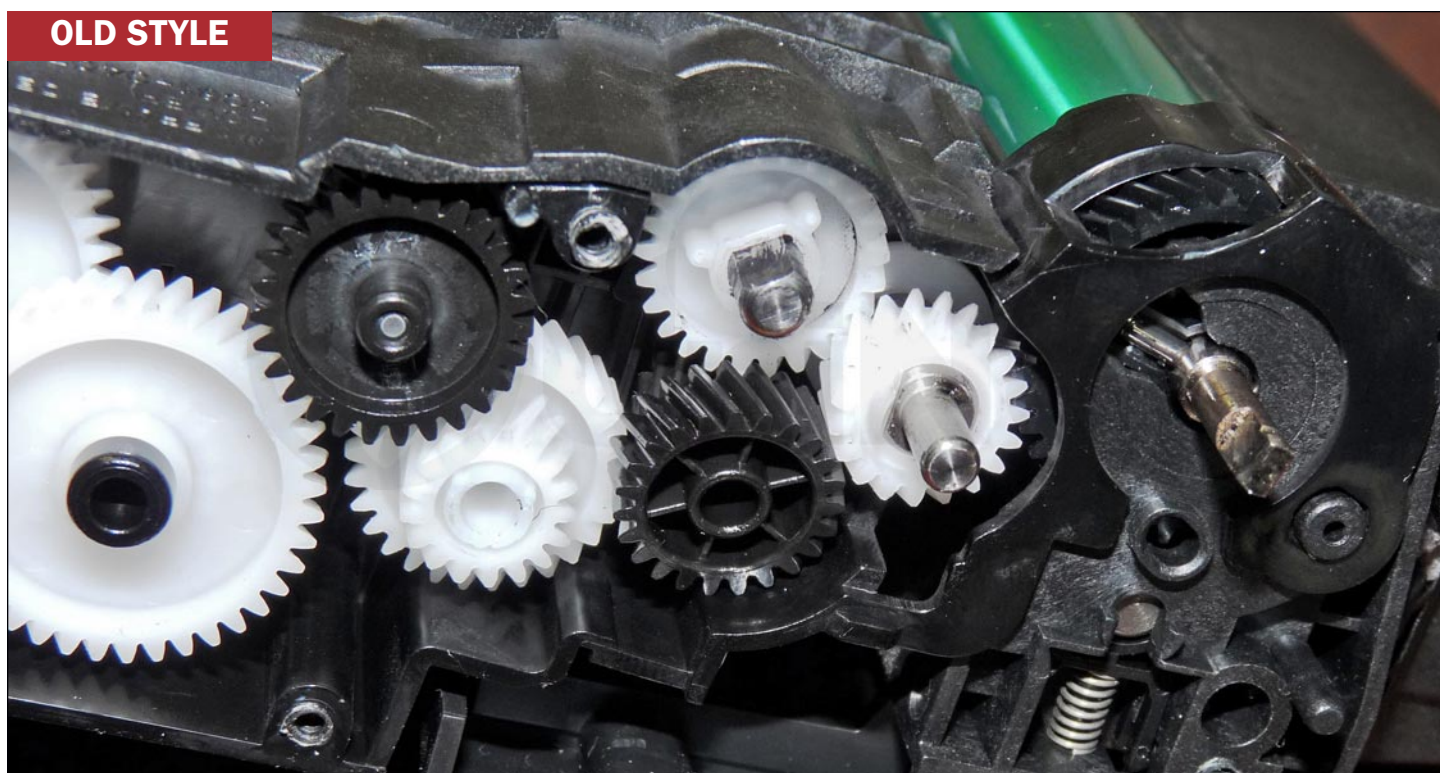
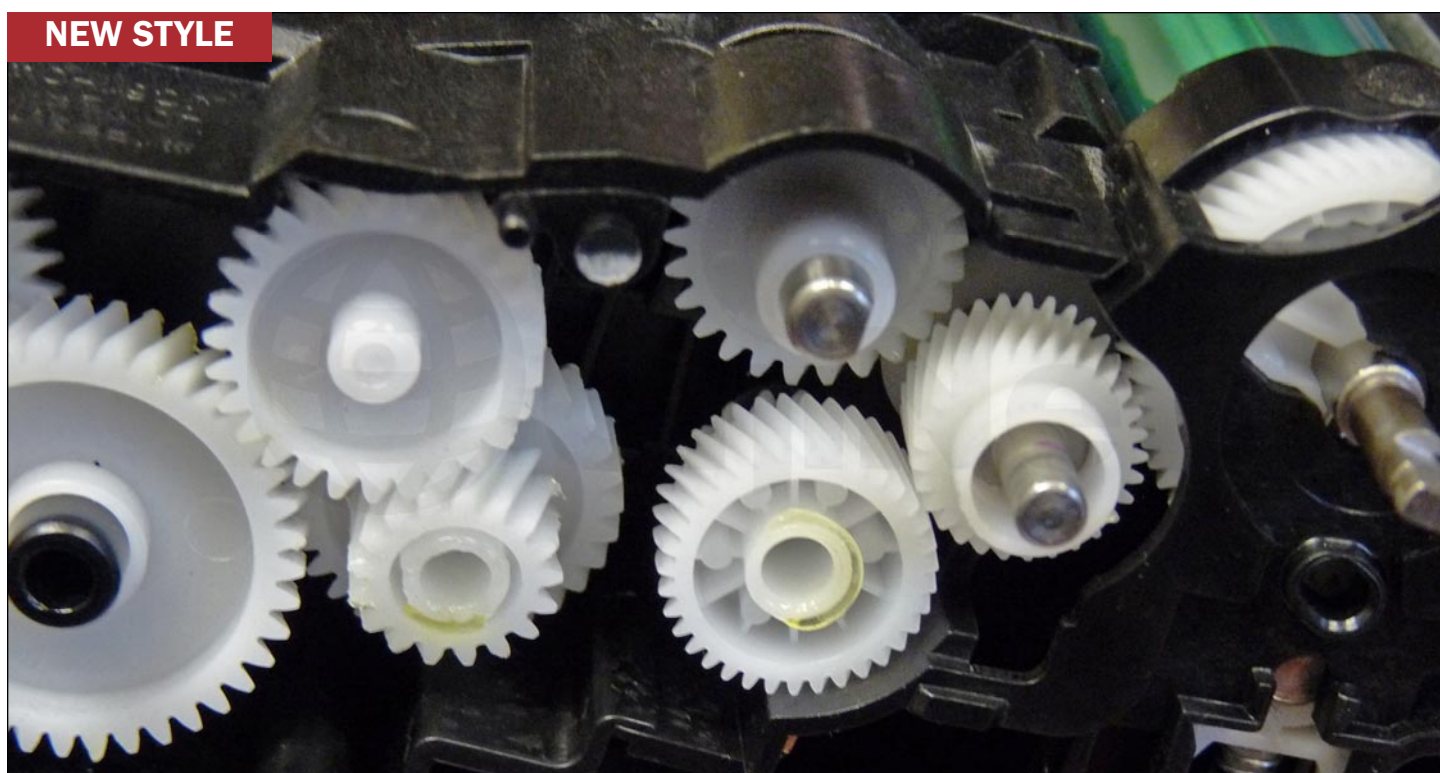
Samsung has made a change to the MLT-D205 cartridges. There is now a new style and an old style. The new style uses a new drive gear with more teeth. The old gear had 39 teeth, and the new one has 59 teeth. It is believed this change was made to enhance the grayscale capability of the cartridges (smoother grayscales).

Shown here are the full gear trains of both the **old** and **new** styles...

UniNet has been working on this since the first cartridges appeared and now has a solution available: **#18694 SuMMiT® drum with gears for use in Samsung ML 3310, 3312, 3710, 3712, 3750, SCX 4833, 5737 (MLT-D205) (59-tooth gear)**

We will of course continue to stock the old version: **#17094 SuMMiT® drum with gears for use in Samsung ML 2950, 2955, 3310, 3312, 3712, 3750, SL-M 2870, 2820, 2670, 2620, SCX 4833, 5737 (MLT-D205) (old type gear)**

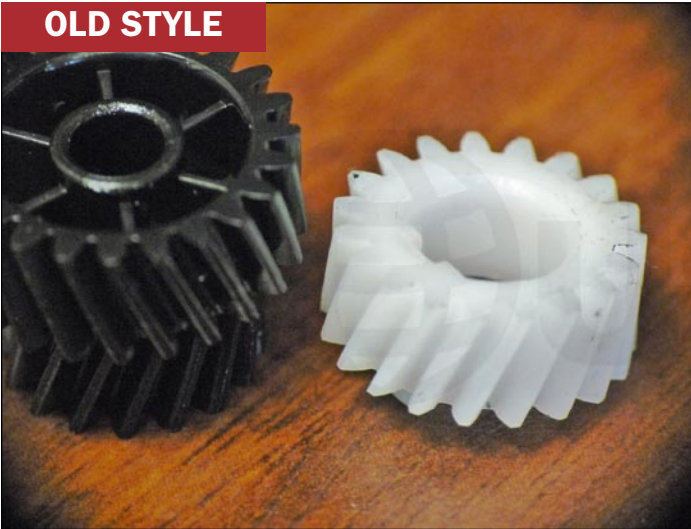
OLD STYLE

In addition to the new drive gear in the drum there are also two new internal cartridge gears.

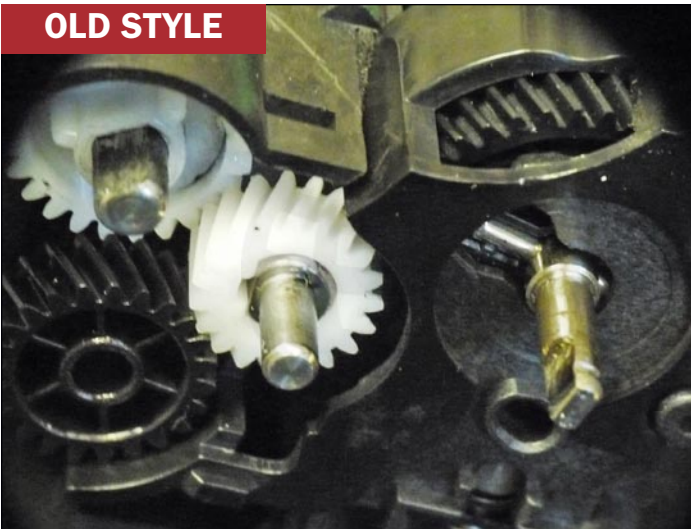
OLD STYLE

Shown are the two old and new gears.

Shown are close-ups of the three new gears, old and new as installed in the cartridge.

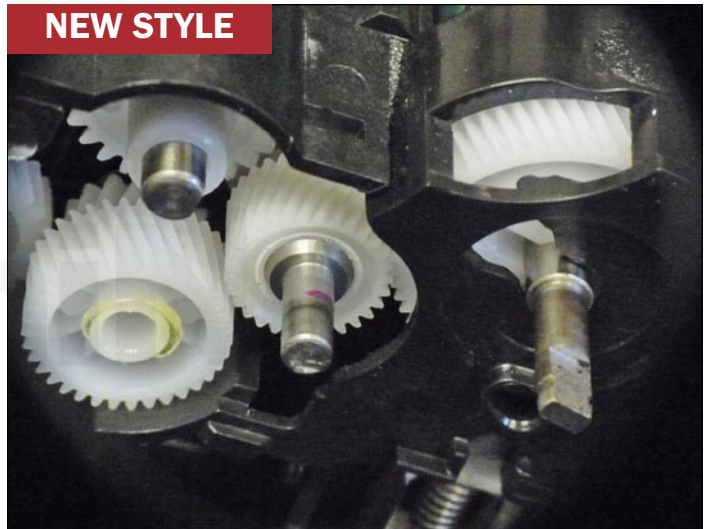
**NEW STYLE**

The old drums will not work in the new cartridges, nor will the new drums work in the old cartridges.

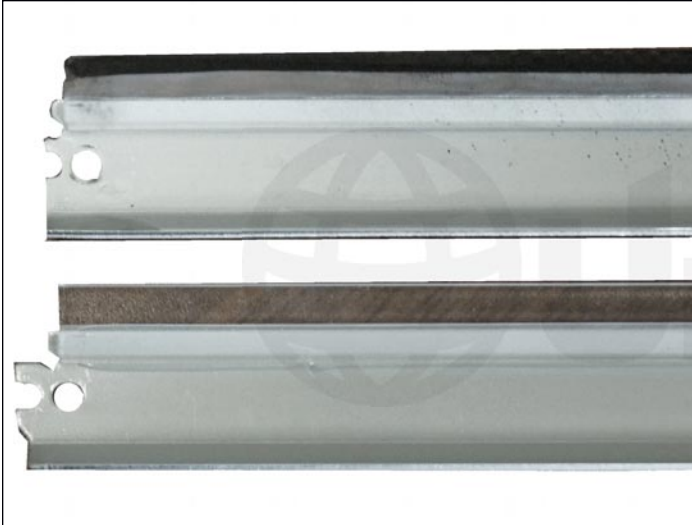
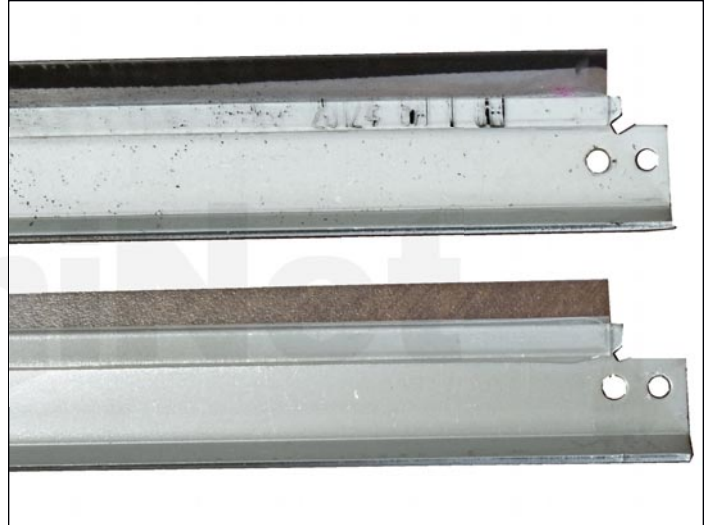
Samsung has made a change to the MLT-D104 cartridges. There are now shipping locks installed on the PCR shafts. These new locks run alongside the edges of the wiper blade as they fit through the cartridge. Because of this change a new wiper blade was needed.

You can easily tell the two versions apart by looking at the top of the cartridge. There are colored plastic shipping locks visible on both the right and left sides. The top cartridge pictured above is the new version.

UniNet is currently developing a new blade for these cartridges, and the instructions for this cartridge have been updated to show the differences between the two blades and the cartridges.

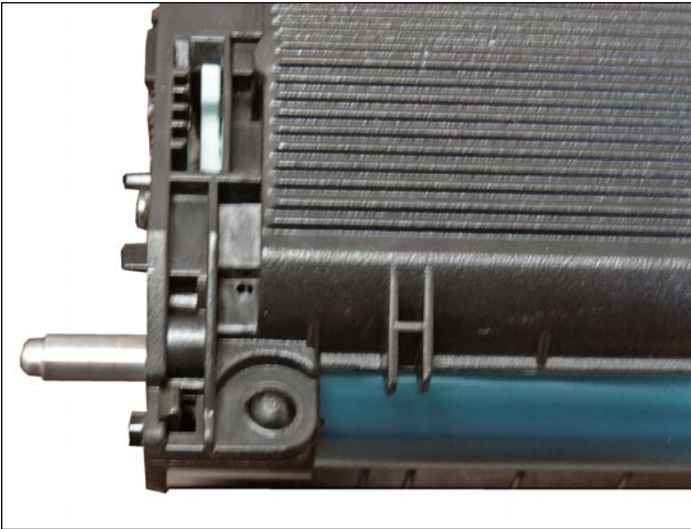
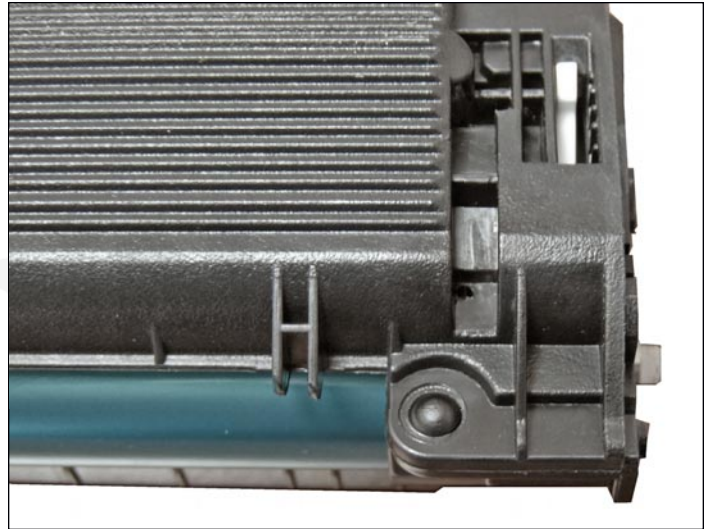
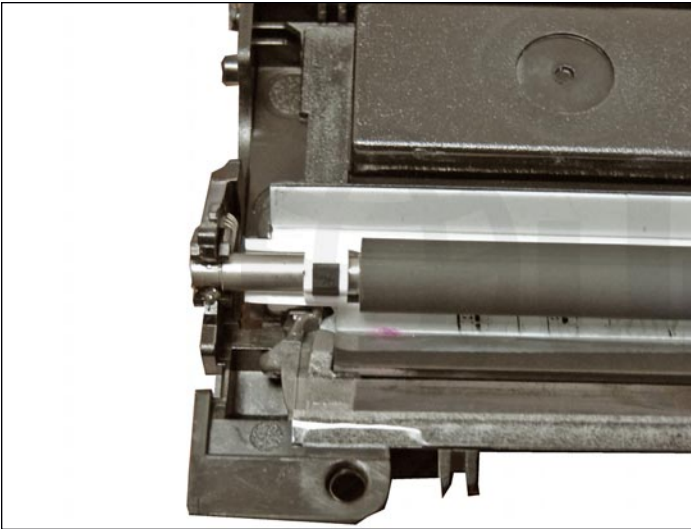
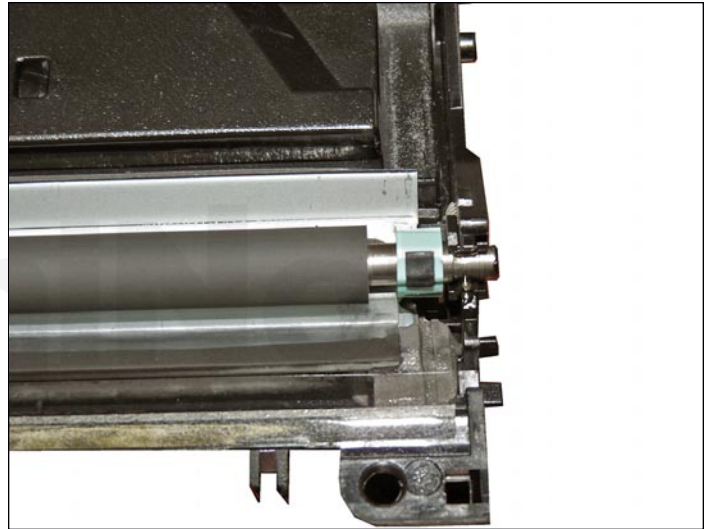
You can see the differences between the two blades.

The top blade is the new version.

Shown are the two versions of the cartridges from the inside. The new version is pictured on top.

As mentioned earlier, new blades for these cartridges are in development.
