BROTHER® HL-6180 DR720

OPC CARTRIDGE REMANUFACTURING INSTRUCTIONS

REMANUFACTURING THE BROTHER HL-6180 DR720 OPC CARTRIDGE

By Mike Josiah and the Technical Staff at UniNet

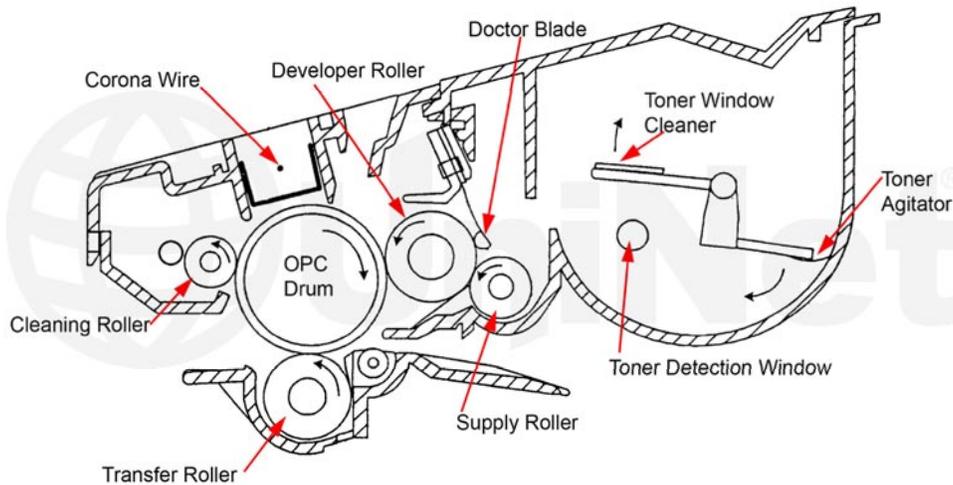
Shown is a general layout of the component locations.

The cleaning section of the drum cartridge no longer consists of a "cleaning brush" it is now a paired system of the cleaning roller assembly and the transfer roller but these rollers only play a minor part. The developer roller now has two jobs. In addition to transferring the good toner to the OPC for printing, it also now cleans off the majority of the waste toner off the drum. This is done by a very complicated series of different electrical charges and a series of directional changes on the drum and developer rollers. The developer roller and drum change direction and charge four times per full drum rotation. This is such a complicated process that the printers actually have a rotation controller PCB with a microcomputer on it to control it all.

The cleaning roller cleans off any remaining toner that the developer roller did not remove. The transfer roller basically self-cleans itself of any residual toner or paper dust that might have accumulated in the printing process.

When the drum is cleaned by the transfer roller the surface potential of the drum is dropped (from 900V to about 200V). At this point the transfer roller and cleaning roller will release the waste toner to the drum. This waste toner is actually then charged by the corona wire so that the developer roller can pick it up and bring it back into the toner hopper. Both rollers release the waste toner at the same time. This was done to keep the print speed high, the power supply smaller and the cost on the two rollers and cartridges down.

The drum unit also now has a small waste chamber next to the cleaning roller. The reason for this waste area is for things like paper dust that do not transfer well. Since there is a paper-cleaning roller before the cartridges in the printer this area in theory should stay fairly empty. The metal roller next to the cleaning roller helps keep the cleaning roller free of anything that does not transfer.

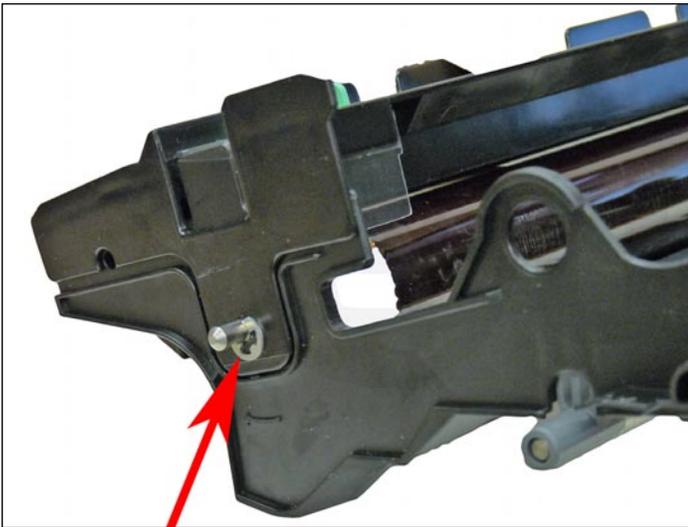
1. Remove the E-ring from the gear side of the drum axle shaft.

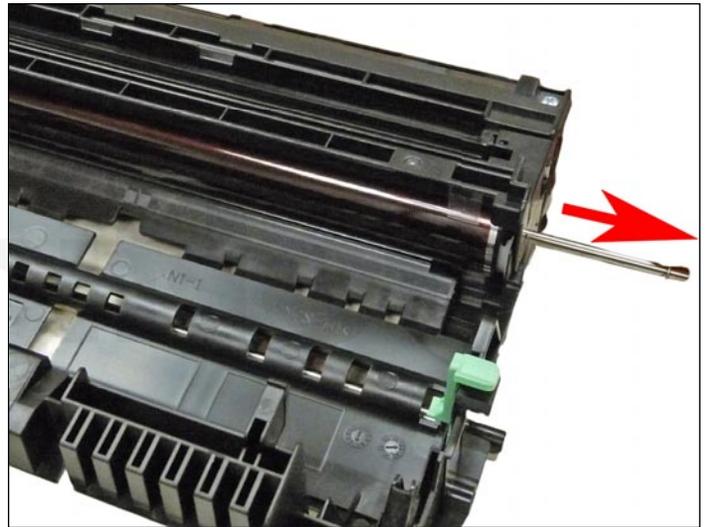
2. Remove the drum axle from the non-gear side of the drum. If you try to pull it out from the gear side, the shaft will jam up on the drum ground-contact, and damage the contact.

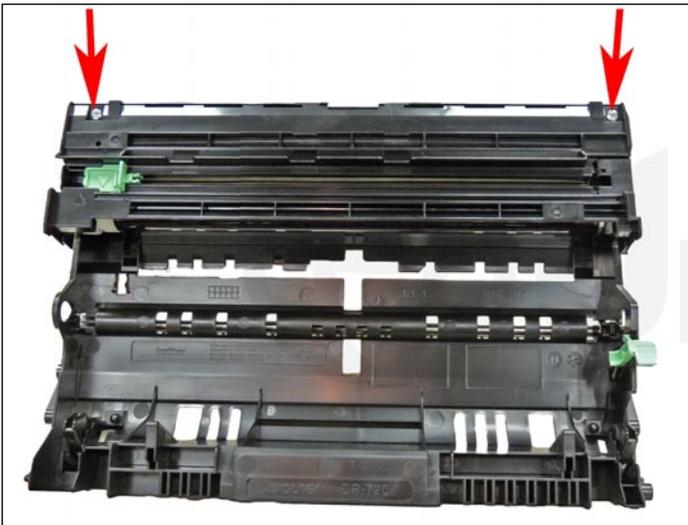
3. Remove the two screws from the top of the corona wire assembly.

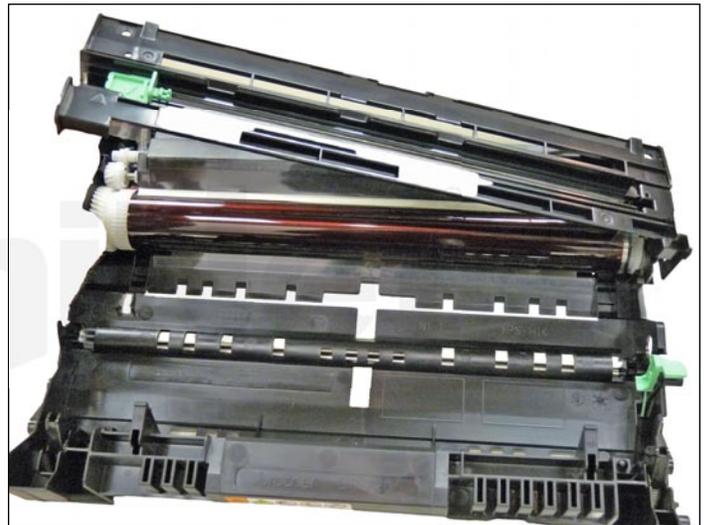
4. Carefully pry up and lift off the top cover/corona wire assembly from the cartridge.

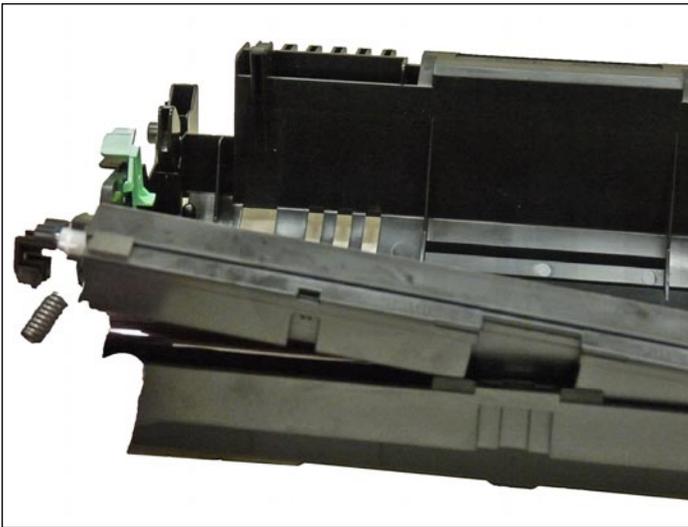
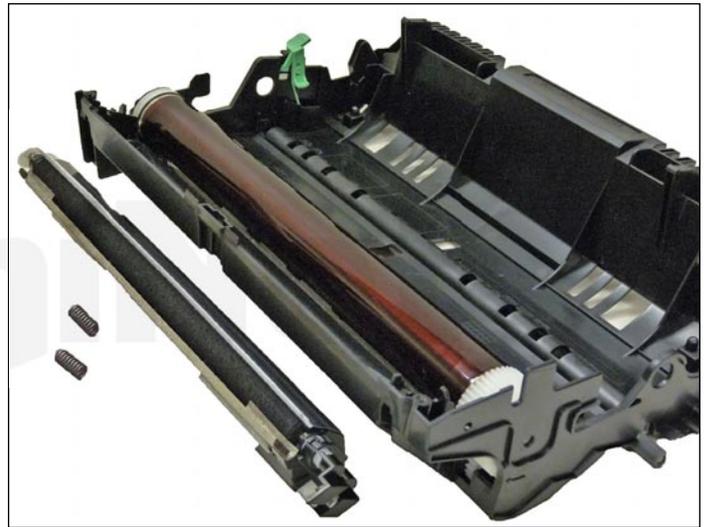
5. Remove the cleaning roller assembly by prying up on the two bottom tabs.

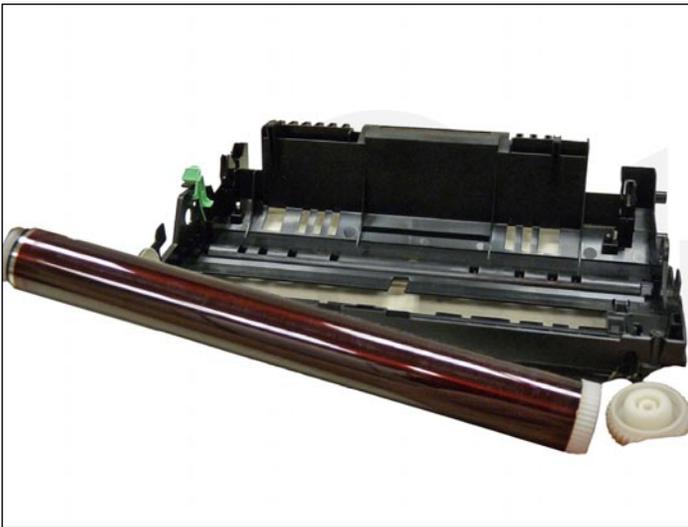
6. Carefully remove the drum.

The large drive gear will come loose.

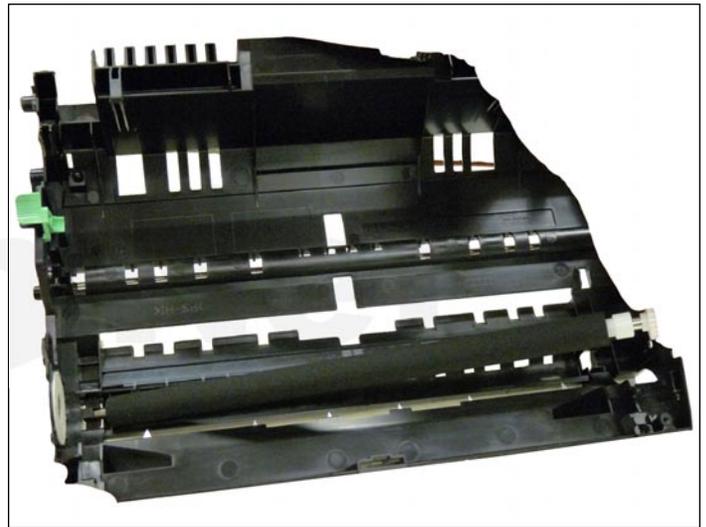
7. Carefully lift out the transfer roller from the gear side. Be very careful not to touch the roller with your skin. As with any transfer roller, the oils naturally present in your skin will be absorbed by the roller and interfere with the transfer process, causing light print.

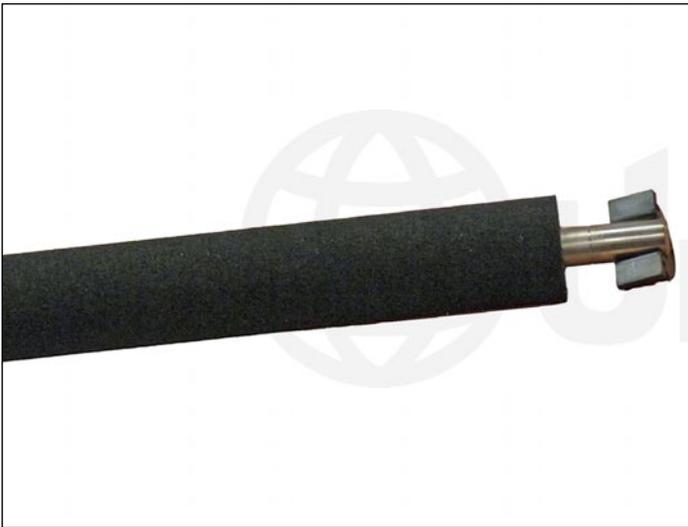
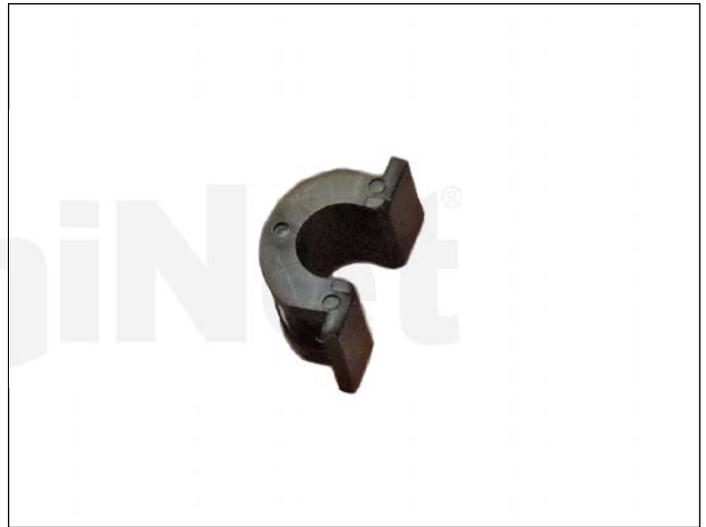
8. **IMPORTANT:** Note that there will be a small black bushing left in the cartridge. This bushing keeps the transfer roller from touching the electrical contacts on the left side of the cartridge. Be very careful not to lose this spacer! The cartridge will either print very light or 1/2 pages if it is missing. If the bushing does not come out with the transfer roller, it is best to remove the bushing while cleaning the cartridge.

9. With compressed air, blow off the transfer roller. Unless you have a statically grounded vacuum, do not vacuum this roller.

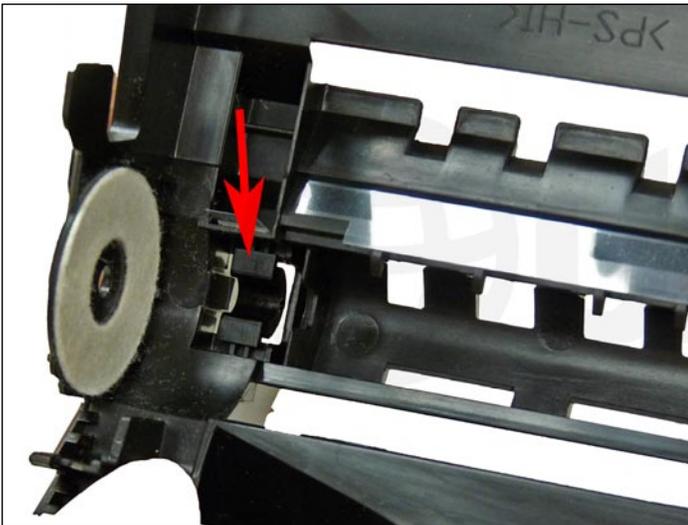
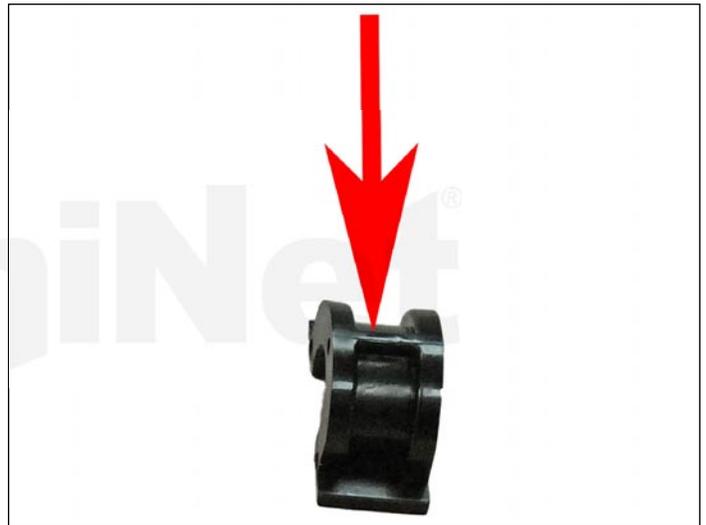
10. Reinstall the small black transfer roller bushing.

The groove in the bushing fits over the two thin rails.

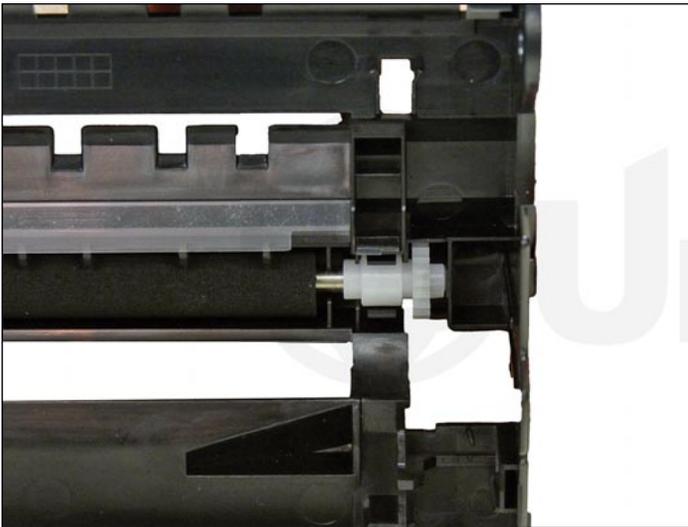
11. Install the transfer roller. Make sure that both the white plastic bushing and gear is clean.

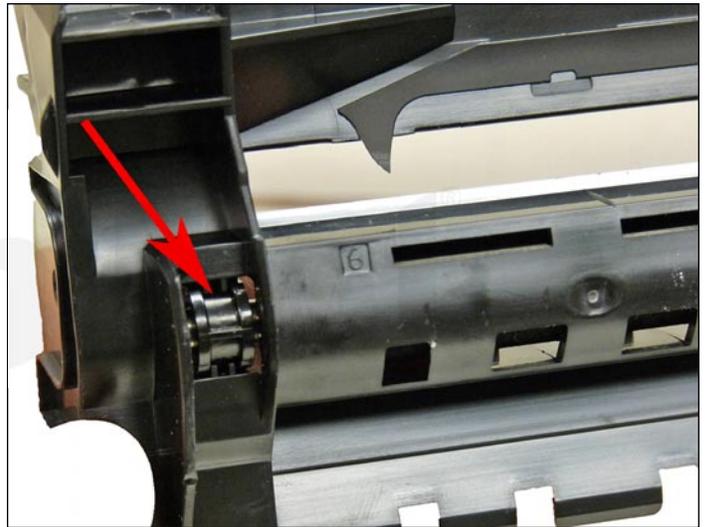
12. Check the outside of the cartridge to make sure that the small black bushing is correctly positioned.

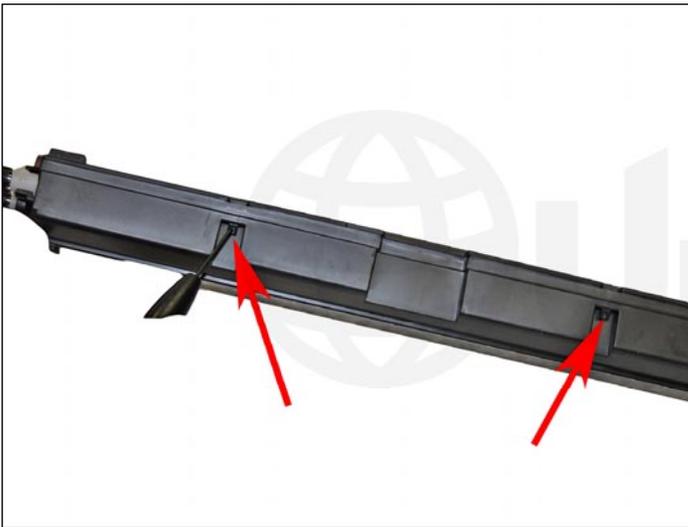
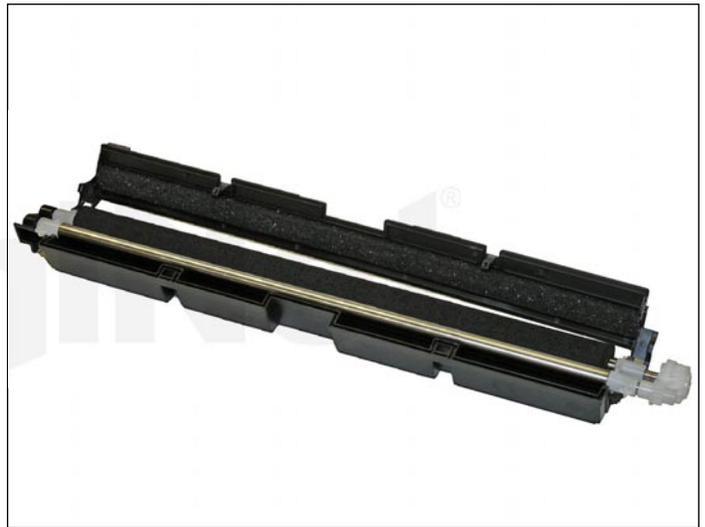
13. On the cleaning roller assembly, pry up on the two tabs and lift off the cover.

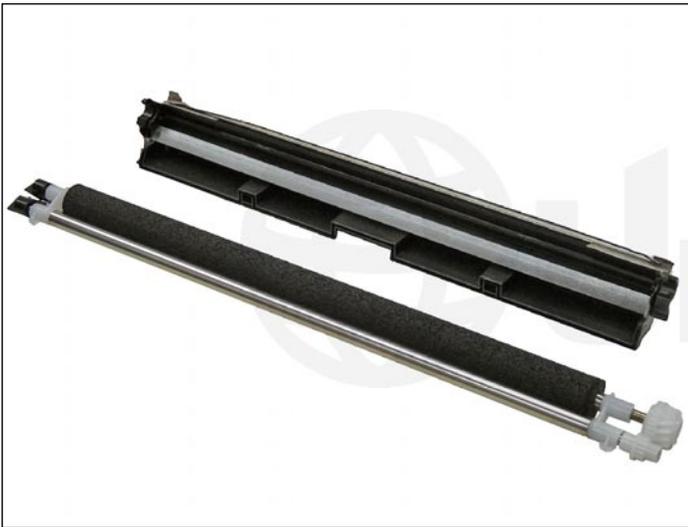
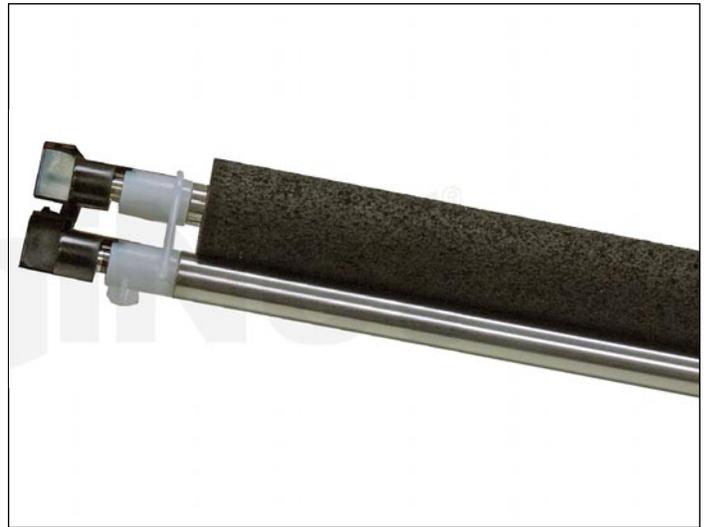
14. Lift out the two rollers.

Be careful not to lose the two black conductive plastic contacts.

Two springs will come loose. Be careful not to lose them.

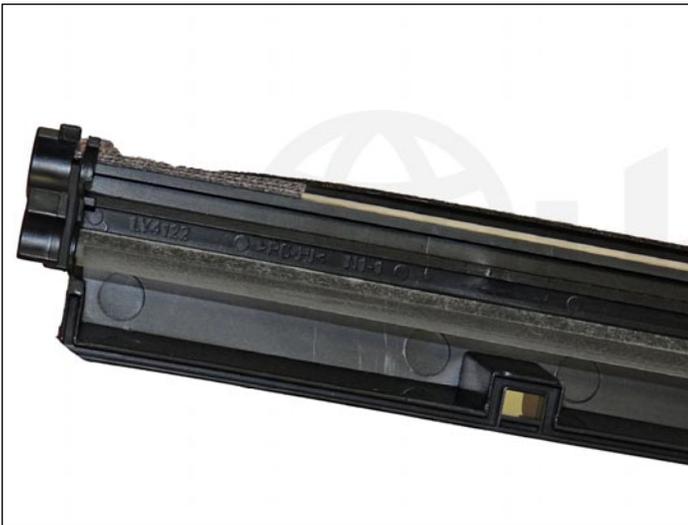
15. Clean out the waste chamber.

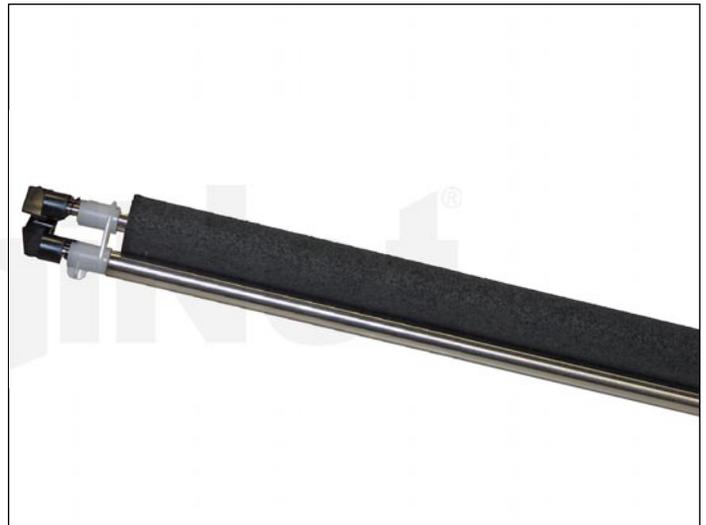
16. Blow off the cleaning roller using compressed air.

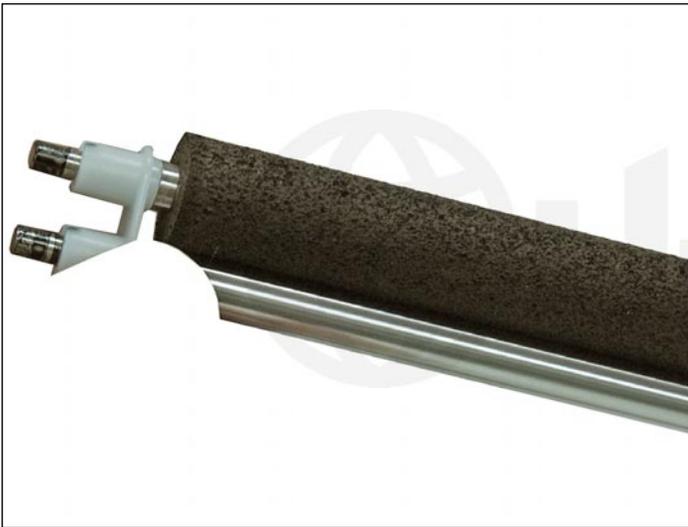
17. Install the rollers into the chamber.

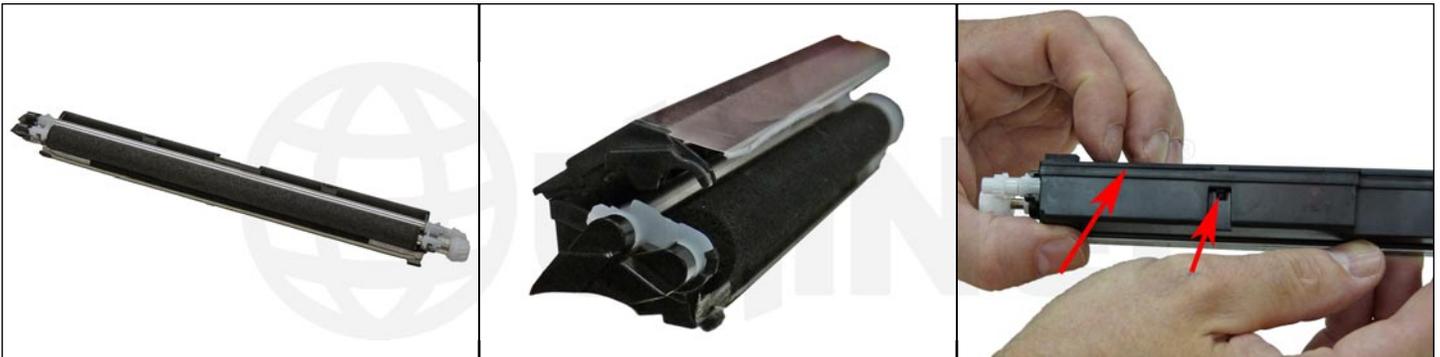
18. Install the cover.

Lock the two tabs in place first then lock the two front tabs.

Make sure the cover is on flat!

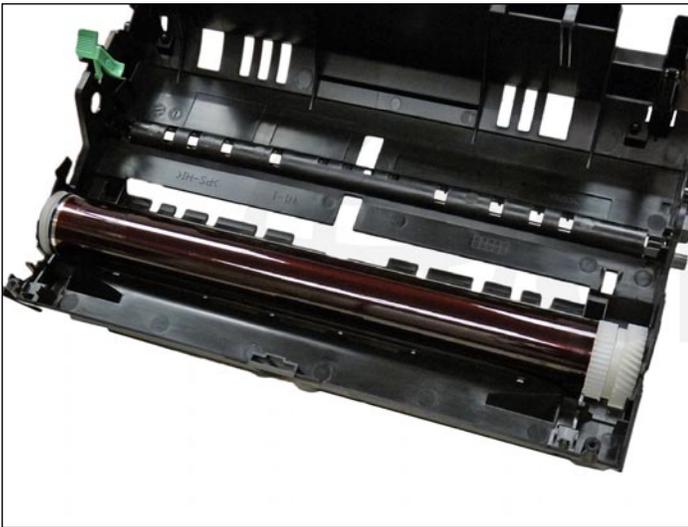
19. Install the drum, hub side first. You will have to compress the hub spring slightly for the drum to fit properly.

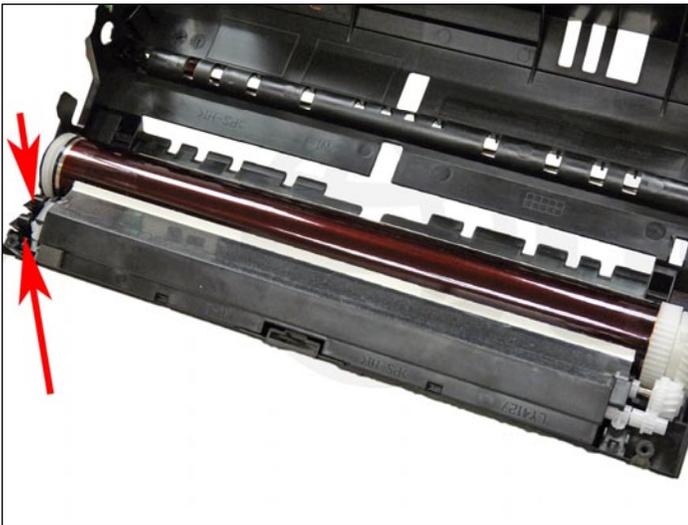
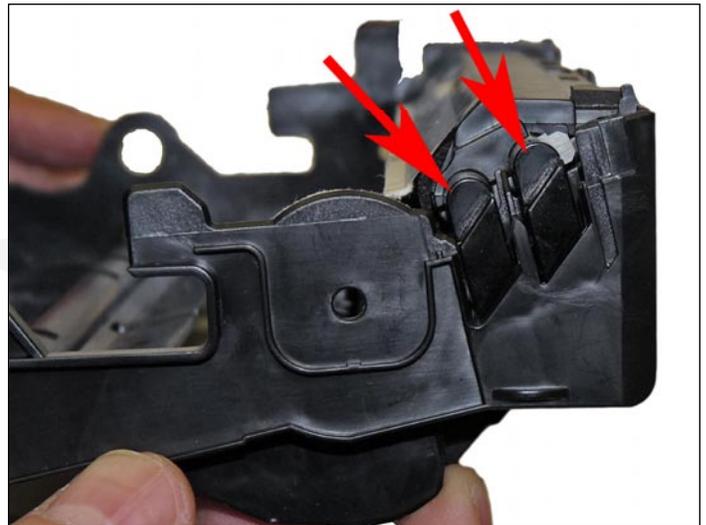
20. Install the cleaning roller assembly into the cartridge.

Make sure the two conductive plastic contacts fit into their slots.

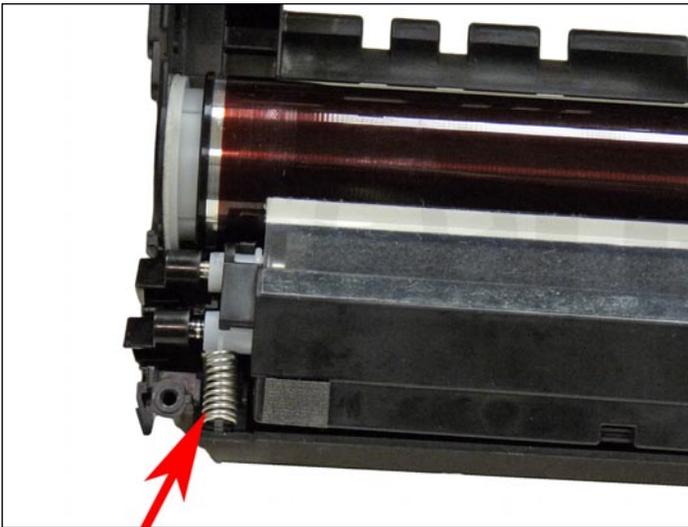
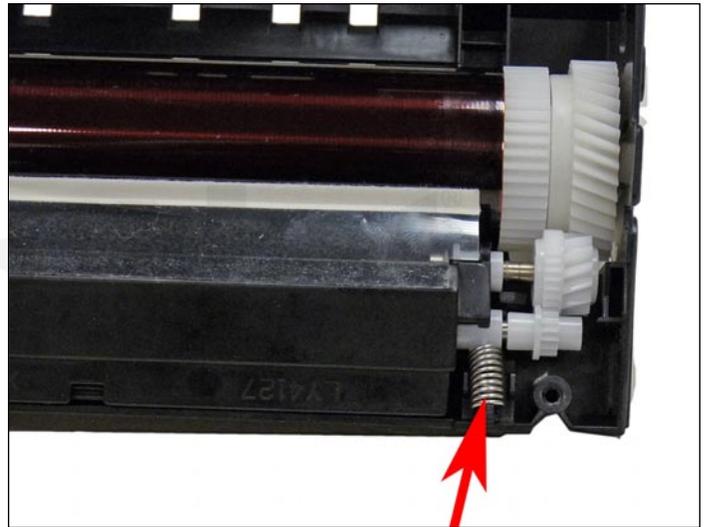
21. Install the two springs on each side of the cleaning roller assembly.

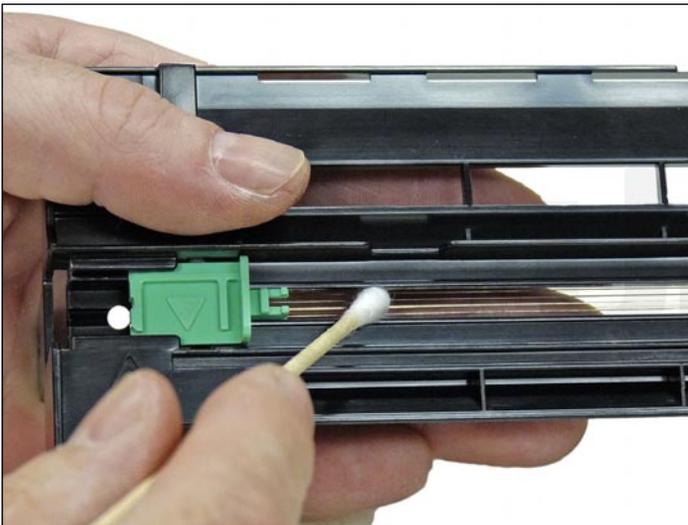
22. Clean the primary corona wire and grid with a cotton swab and alcohol.

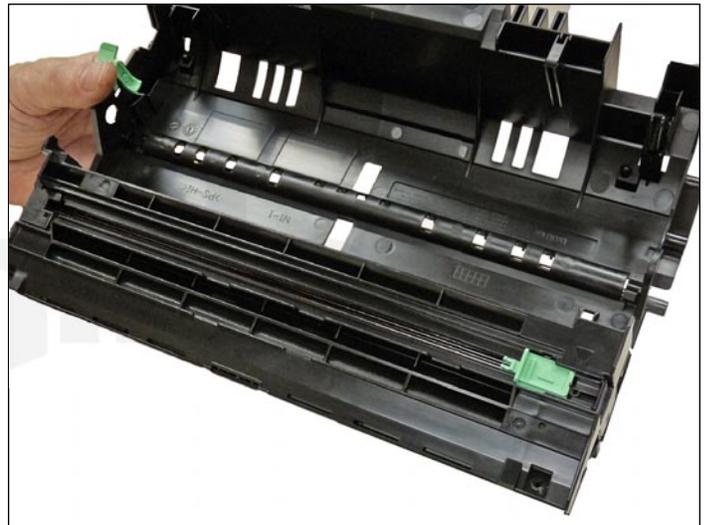
23. Install the top cover pressing down so it snaps in place.

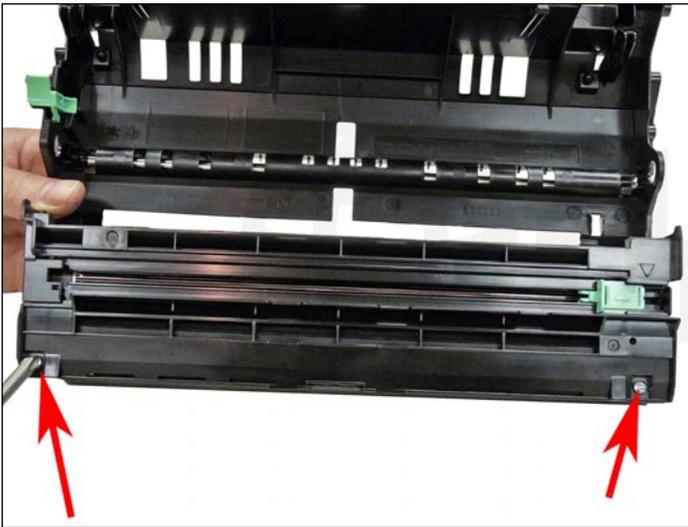
24. Install the two screws on the top of the cover.

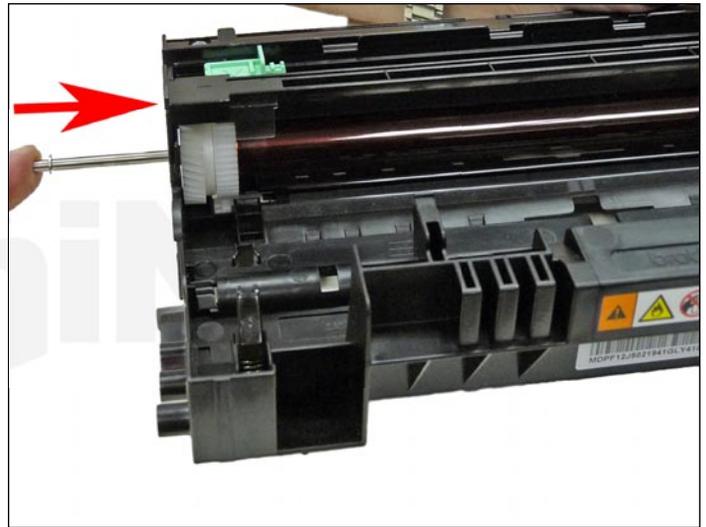
25. Install the drum axle from the drum gear side of the cartridge.

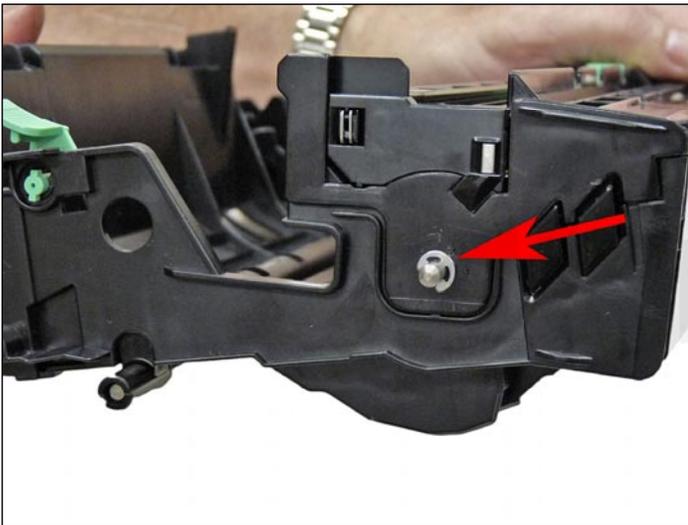
26. Install the e-ring on non-gear side of the drum axle shaft. Press the sidewall in slightly so that the e-ring slot is accessible.
