Okidata OL-1200 Toner Cartridges

DOC-0268

OVERVIEW

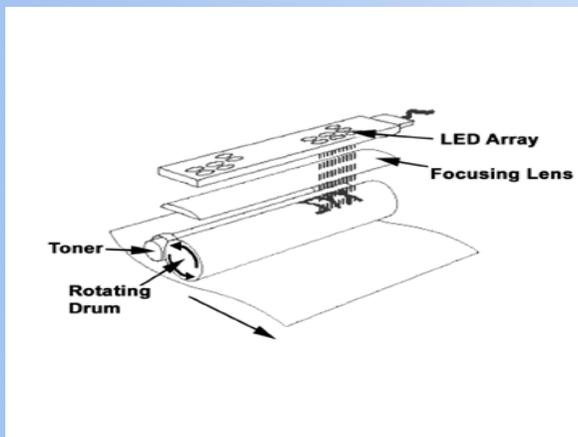
DIAGRAM 1

As with most other Okidata printers these are LED (Light Emitting Diode) engines not laser. LED print heads use a single, pixel-size, modulating light source to recreate images. This beam is fired from a stationary array containing thousands of tiny LEDs. Light from each diode passes through a focusing lens onto the image drum. See Diagram #1. Laser printers also use a single light source, but the beam is aimed at a revolving mirror (Scanner) that reflects it through a series of focusing lenses, off a stationary mirror to the drum. The results are basically the same, but the LED printers use hardly any moving parts, and use less power. The main downfall of this type of printer is that the LED array is mounted directly above the drum unit, and tends to get dirty. In fact Okidata recommends that the array be cleaned each time the toner cartridge is changed. New and good aftermarket toner kits come with alcohol wipes and a lens cloth. A dirty LED lens will show up as either light/splotchy prints, white spots where there should be black, or "fuzzy" print. Cleaning instructions will follow at the end of this article.

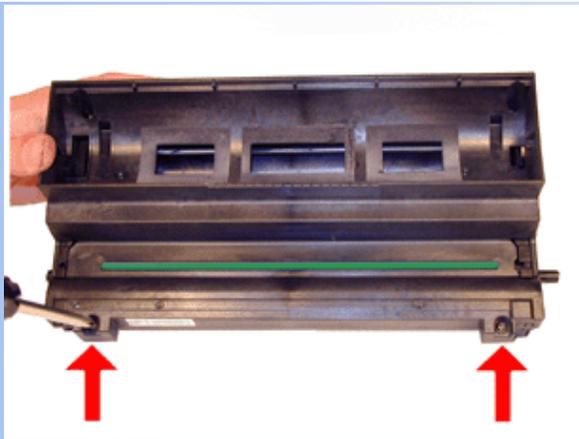
DIAGRAM 2

1. Vacuum the outside of the cartridge thoroughly, especially the exposed Toner Hopper. If the toner tube is still installed, remove it now.
2. Remove the front two Phillips head screws. See Diagram #2.
3. Remove the two Phillips head screws located inside the toner hopper. See Diagram #3.
4. Release the two front tabs located on either side of the front screw holes. See Diagram #4.
5. Release the two side tabs located on either side of the cartridge. See Diagram #5.

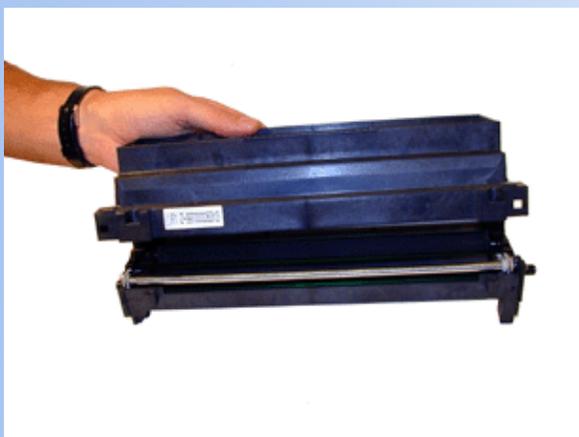
DIAGRAM 6

6. Take off the top cover by lifting up from the toner supply side, and sliding forward. Be careful of the thin gasket on the back rail. It sits loosely in it's slot and can be easily vacuumed up. See Diagram #6.
7. Vacuum the remaining toner out of the supply area. Be careful not to damage the Feed Roller Assembly
8. Carefully remove the PCR/cleaning roller assy. See Diagram #7. Carefully blow off the entire assy. with clean compressed air. Wipe both the rollers down with a clean lint free cloth. The metal roller helps keep the charge even, and helps keep the PCR clean.
9. Remove the three screws on the right side end cap. (two on the side and one on top). See Diagram #8.
10. Remove the right side end cap. See Diagram #9.

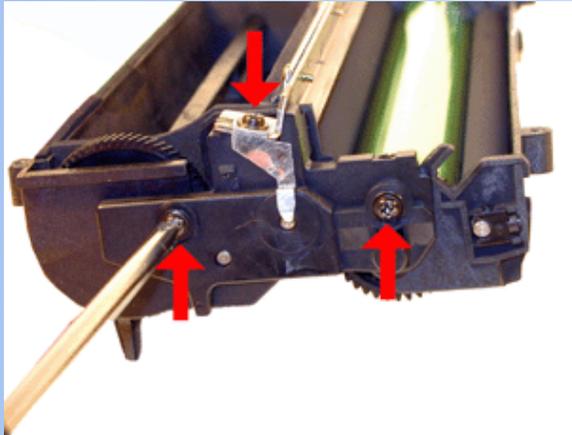
DIAGRAM 10

11. Remove the three screws on the left side end cap. (two on the side and one on top). See Diagram #10.
12. Remove the left side end cap. See Diagram #11.
Be careful of the metal contact plate. It will come loose when the screw is removed. See Diagram #12.
13. From the small gear side. Press the drum up from the bottom. Remove the drum. See Diagram #13.

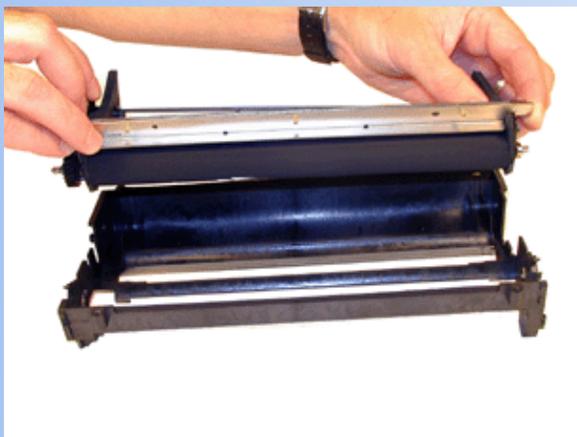
DIAGRAM 14

14. The Static Roller/Dr. Blade/Feed Roller Assy. can be removed as a complete unit by lifting up the vertical foam gasket on each side. See Diagram #14.
15. Carefully blow off the entire assy. with clean compressed air. Pay special attention to the feed roller. Vacuuming is not recommended as the process can create a static field on the feed roller that will cause an uneven flow of toner.

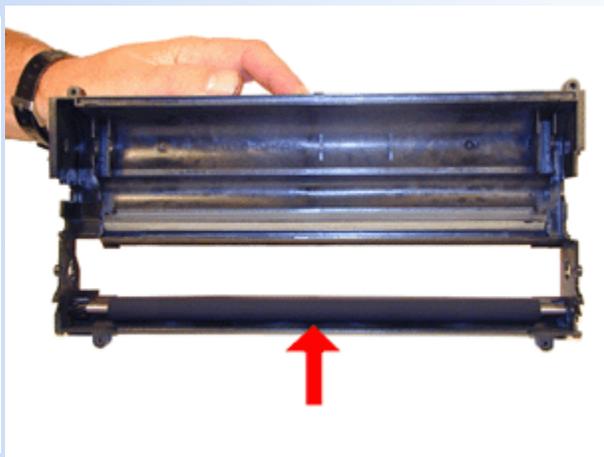
DIAGRAM 15

16. If the Static roller has a buildup of toner that will not come off, the bushing can be removed, freeing the roller. Try wiping the roller off with a dry lint free cloth first. If the buildup remains, clean it with a good rubber roller cleaner.
17. Clean the foam cleaning roller. Vacuuming is not recommended as the process can create a static field on the cleaning roller that will cause streaking. The cleaning roller takes the place of the wiper blade. It has an electrical charge placed on that attracts the excess toner to it. Removing and replacing the roller is very difficult. For this reason, we recommend that the roller be cleaned while in the cartridge. See Diagram #15.

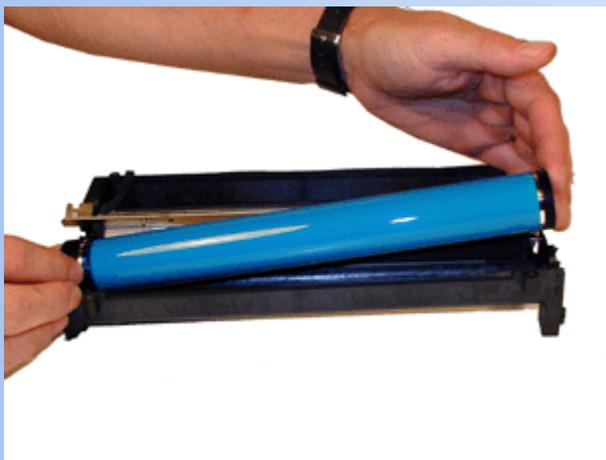
DIAGRAM 16

1. Install the new drum. NOTE: due to the fact that the OEM drum has at least 24,000 pages on it, we highly recommend that the drum be replaced. See Diagram #16.
2. Replace the PCR/Cleaning roller Assembly. Make sure to put the white bushing on the left, and the black bushing to the right. See Diagram #17.
3. Install the right side (Large) end cap. Make sure that all the posts fit into the end cap bushings correctly. Do not force the end cap on! If the end cap does not fit easily, take it off, look for a bushing out of place and re-install. See Diagram #18.

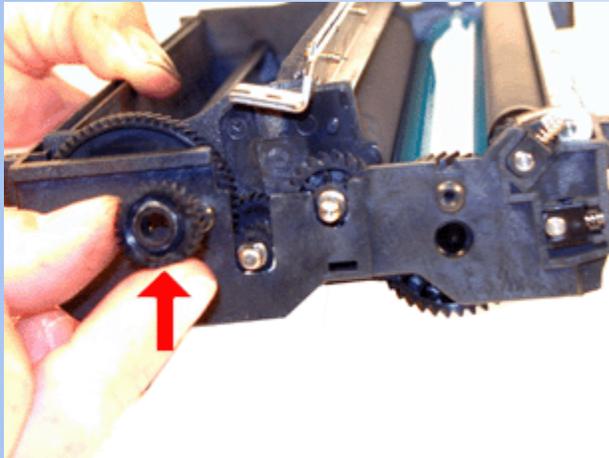
DIAGRAM 19

4. Install the left side end cap. Place the loose gear in first, make sure the end cap shaft fits into it properly. Do not force the end cap on! If the end cap does not fit easily, take it off, look for a bushing out of place and re-install. See Diagram #'s 19, 20,& 21.

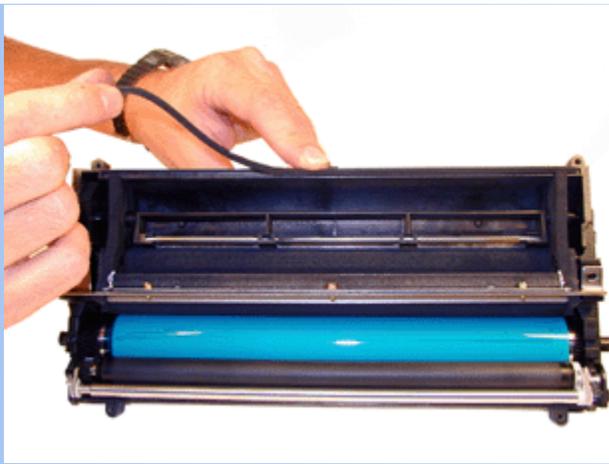
DIAGRAM 22

5. Check to make sure the thin foam gasket is in the correct place. Replace the top cover and four screws. Make sure that the four tabs lock into place. As with the end caps, do not force the cover in place. If it doesn't fit correctly, take it off and try again. Note that the front edge of the cover locks the PCR springs in place. See Diagram #'s 22 & 23.

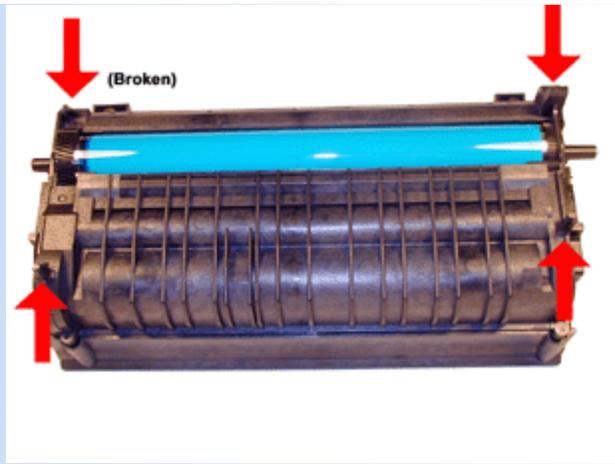
DIAGRAM 25

3. If you are experiencing uneven print that does not seem to follow any sort of pattern, one of the cartridge legs are probably broken. If this is the case the cartridge should not be used, save it for parts only. There is no reliable way to fix a broken leg. See diagram # 25.

One major point to check before you start is to check the four legs that the cartridge stands on. If any of them are broken, the cartridge should be kept for parts only. With one leg broken, the cartridge will tend to move during printing and you will at best get uneven prints, at worst a paper jam. See the troubleshooting chart for more information and pictures of the legs.
