BROTHER® HL-L2300 SERIES DR630 DRUM CARTRIDGE REMANUFACTURING INSTRUCTIONS

REMANUFACTURING THE BROTHER HL-L2300 SERIES DR630 DRUM CARTRIDGE

By Mike Josiah and the Technical Staff at UniNet

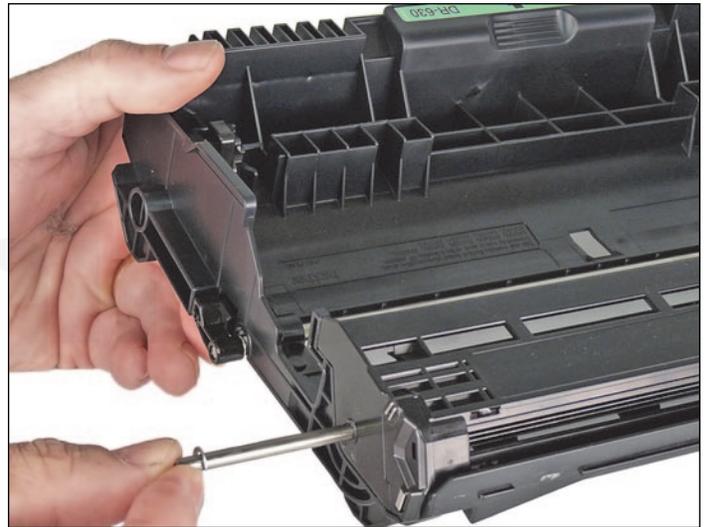
3. Remove the axle from the left side.

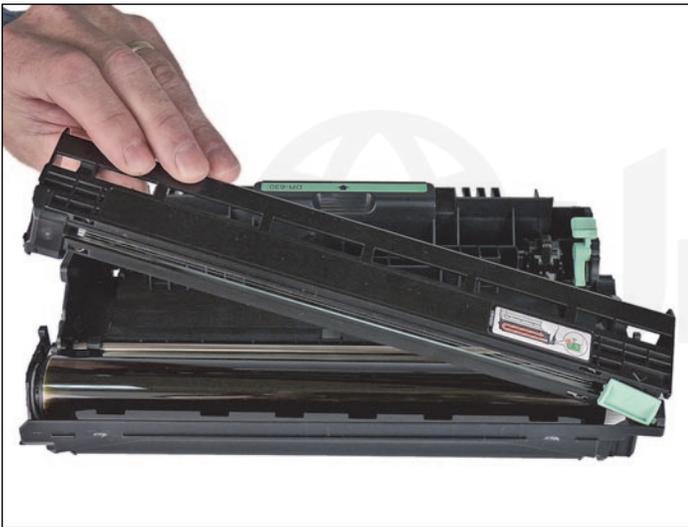
4. Lift off the Corona Wire Assembly.

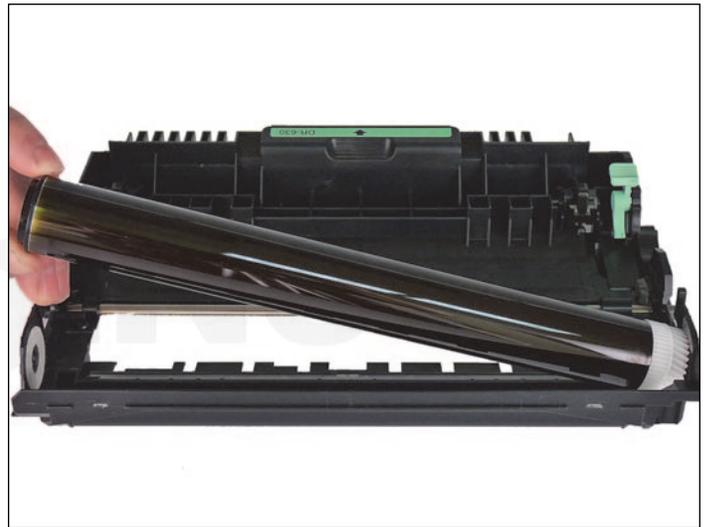
5. Remove the drum.

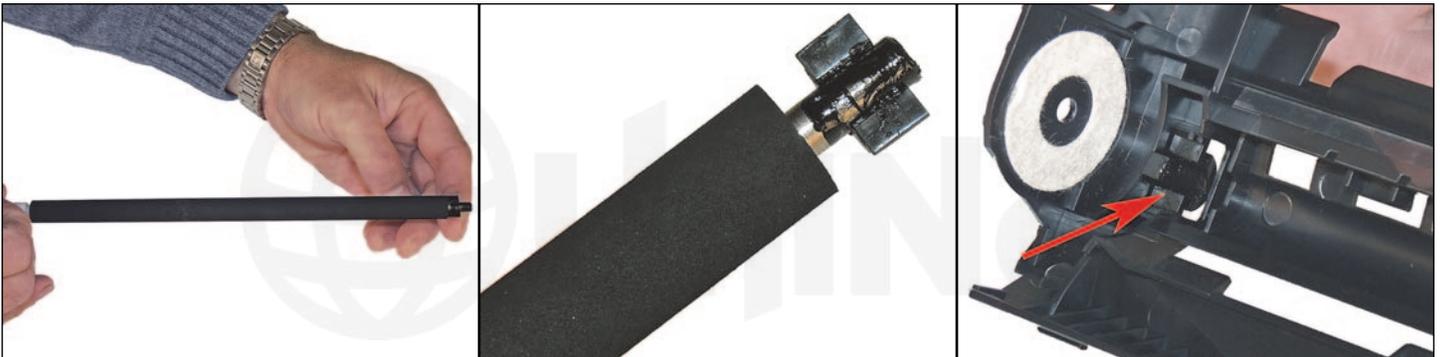
7. Clean the Transfer Roller with compressed air or a toner approved vacuum.

Clean and replace the conductive grease from the 1/2 bushing and the left end of the roller.

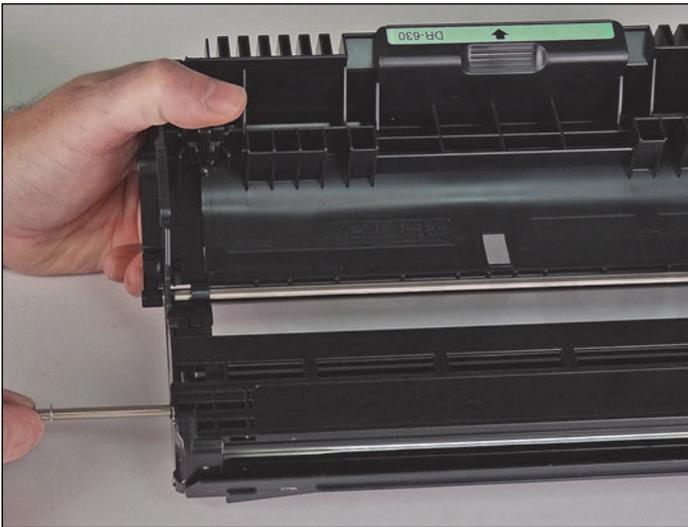
13. Install the drum axle from the left side.
